# Case Study

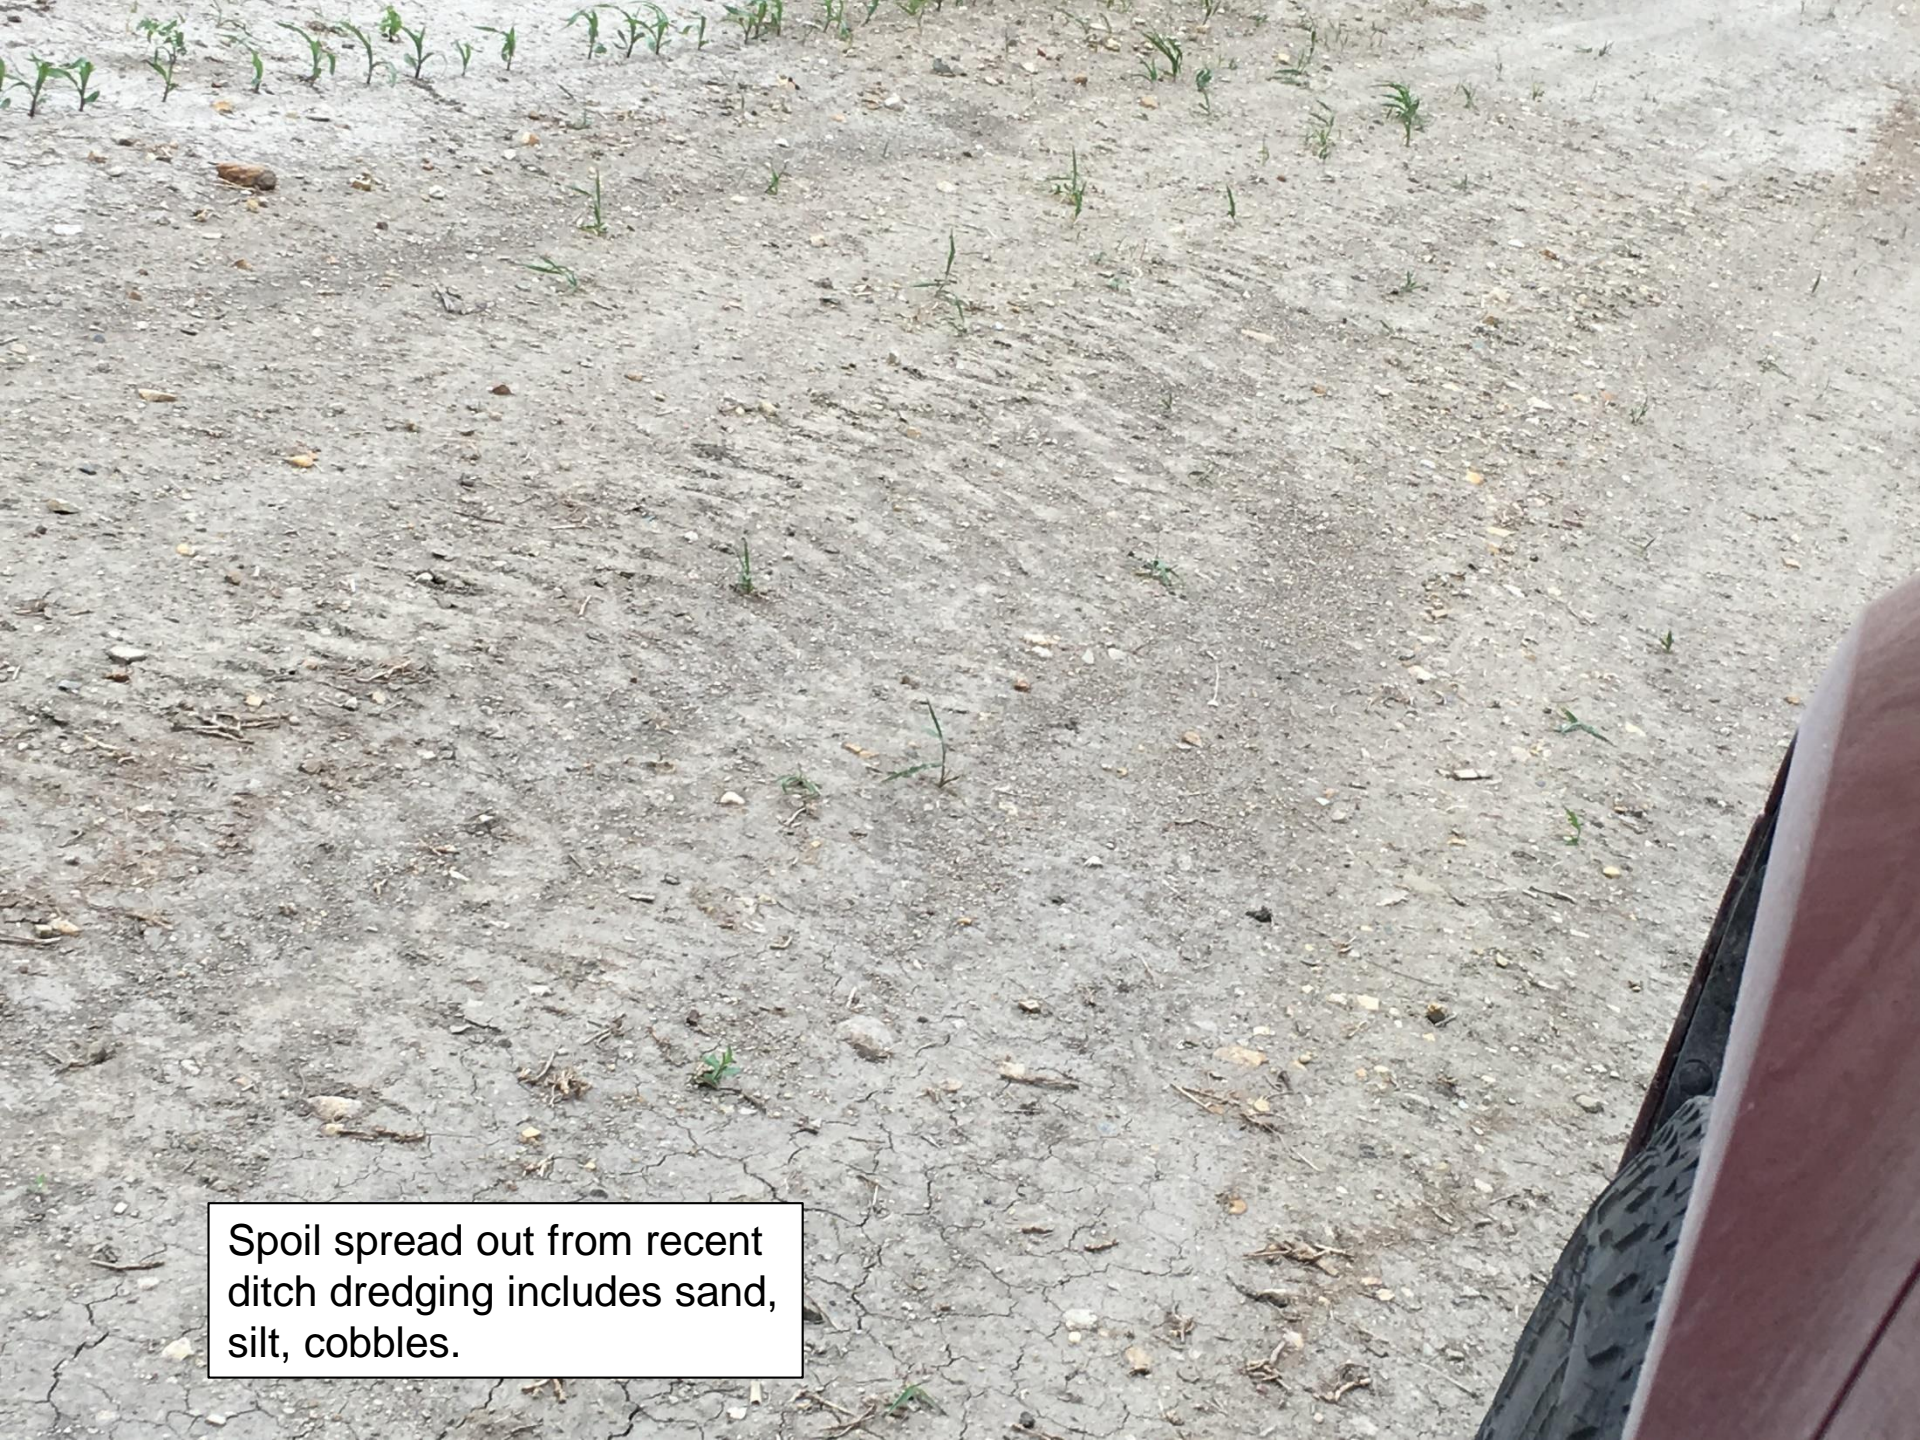
Spoil spread out from recent ditch dredging includes sand, silt, cobbles.

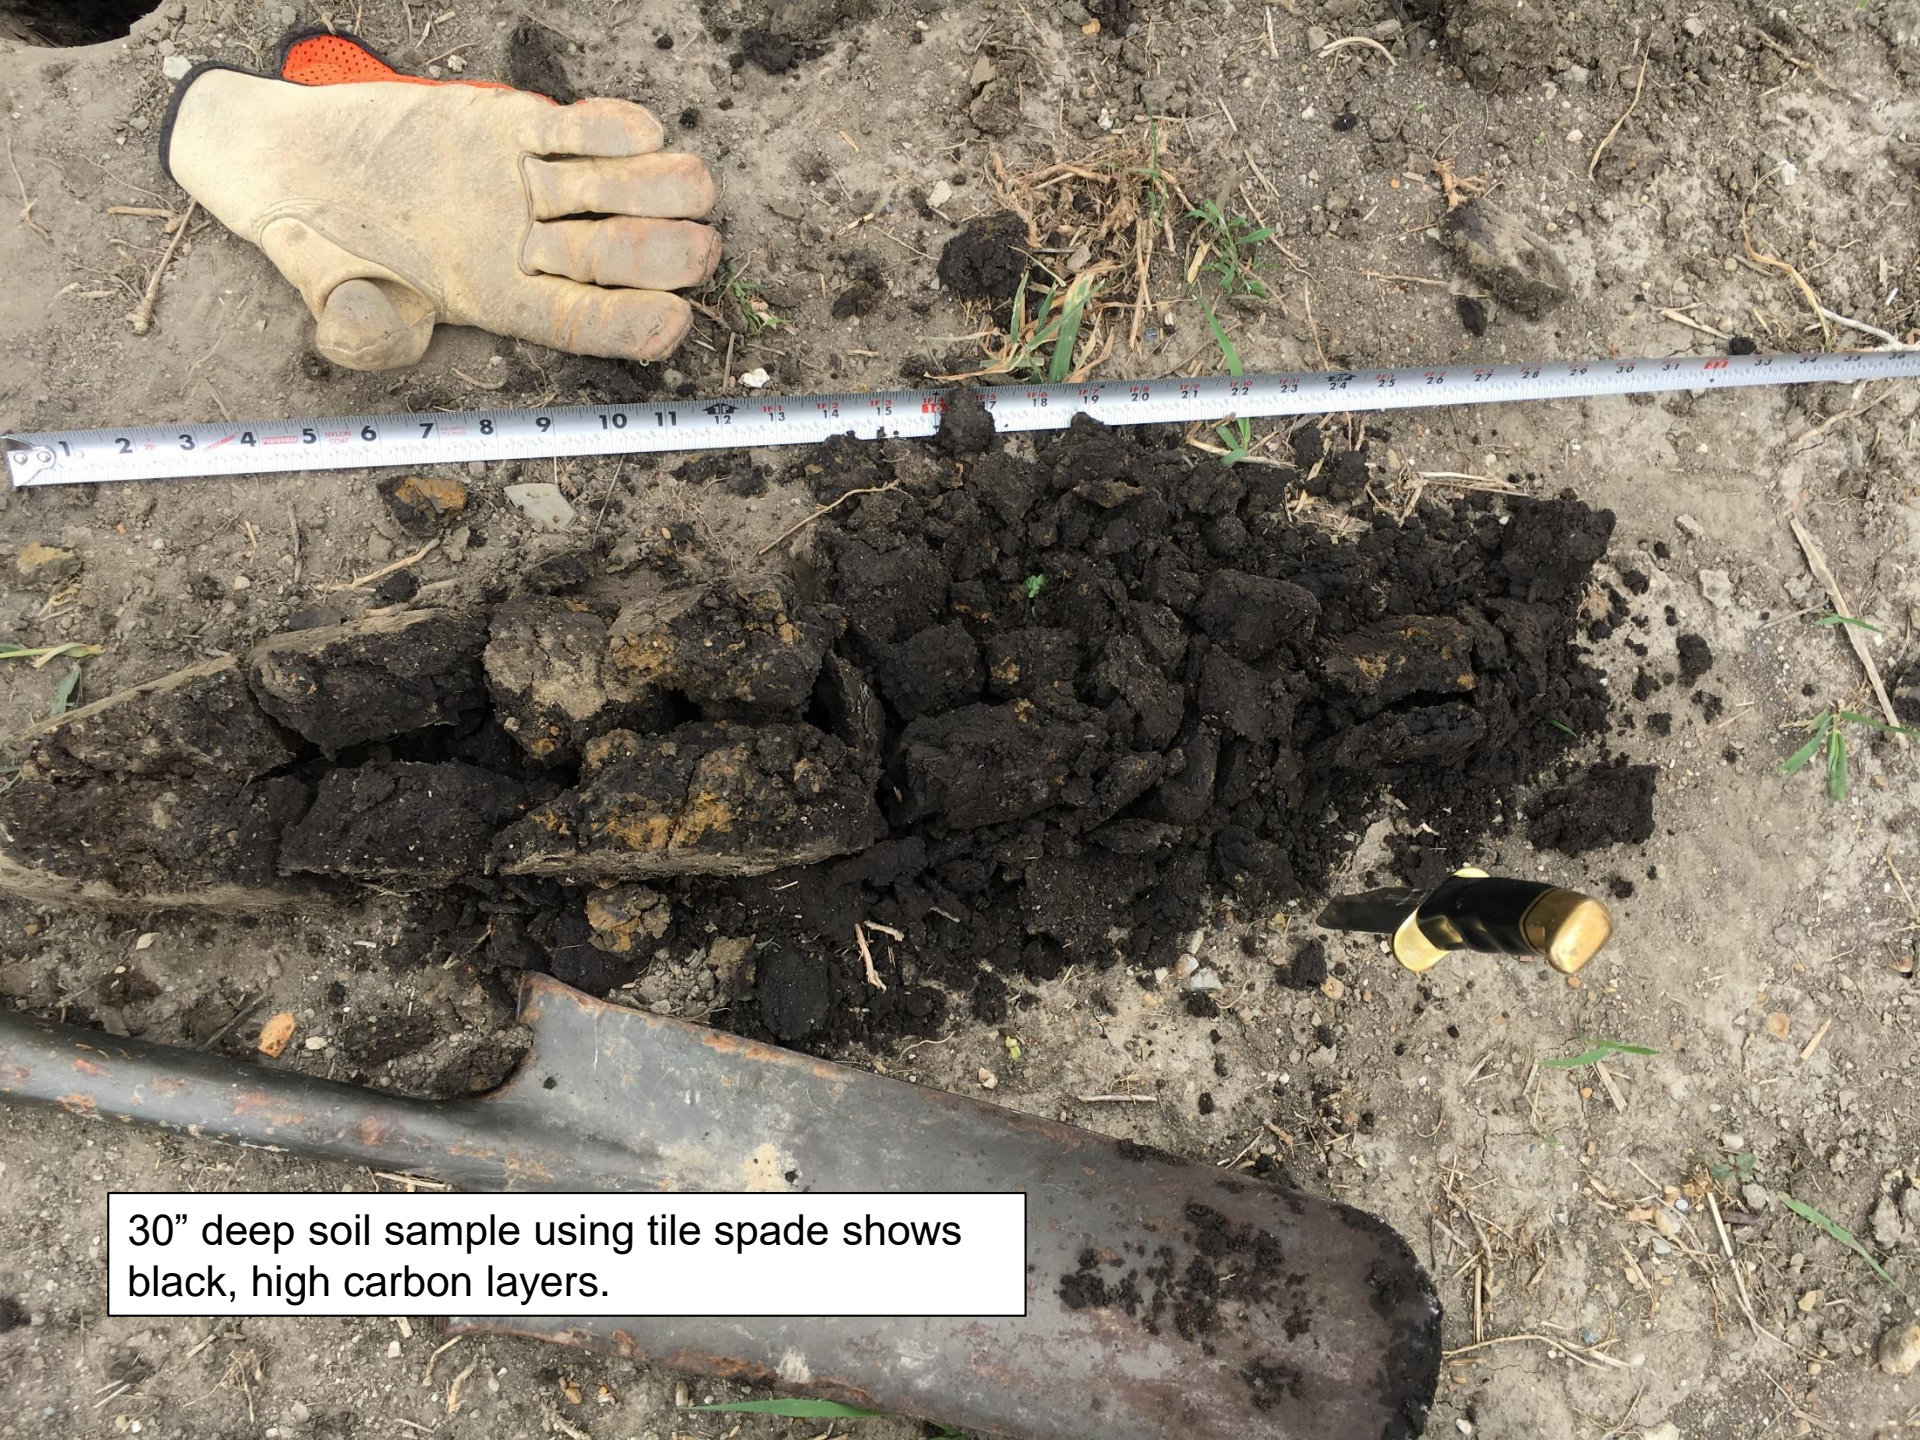
30" deep soil sample using tile spade shows black, high carbon layers.

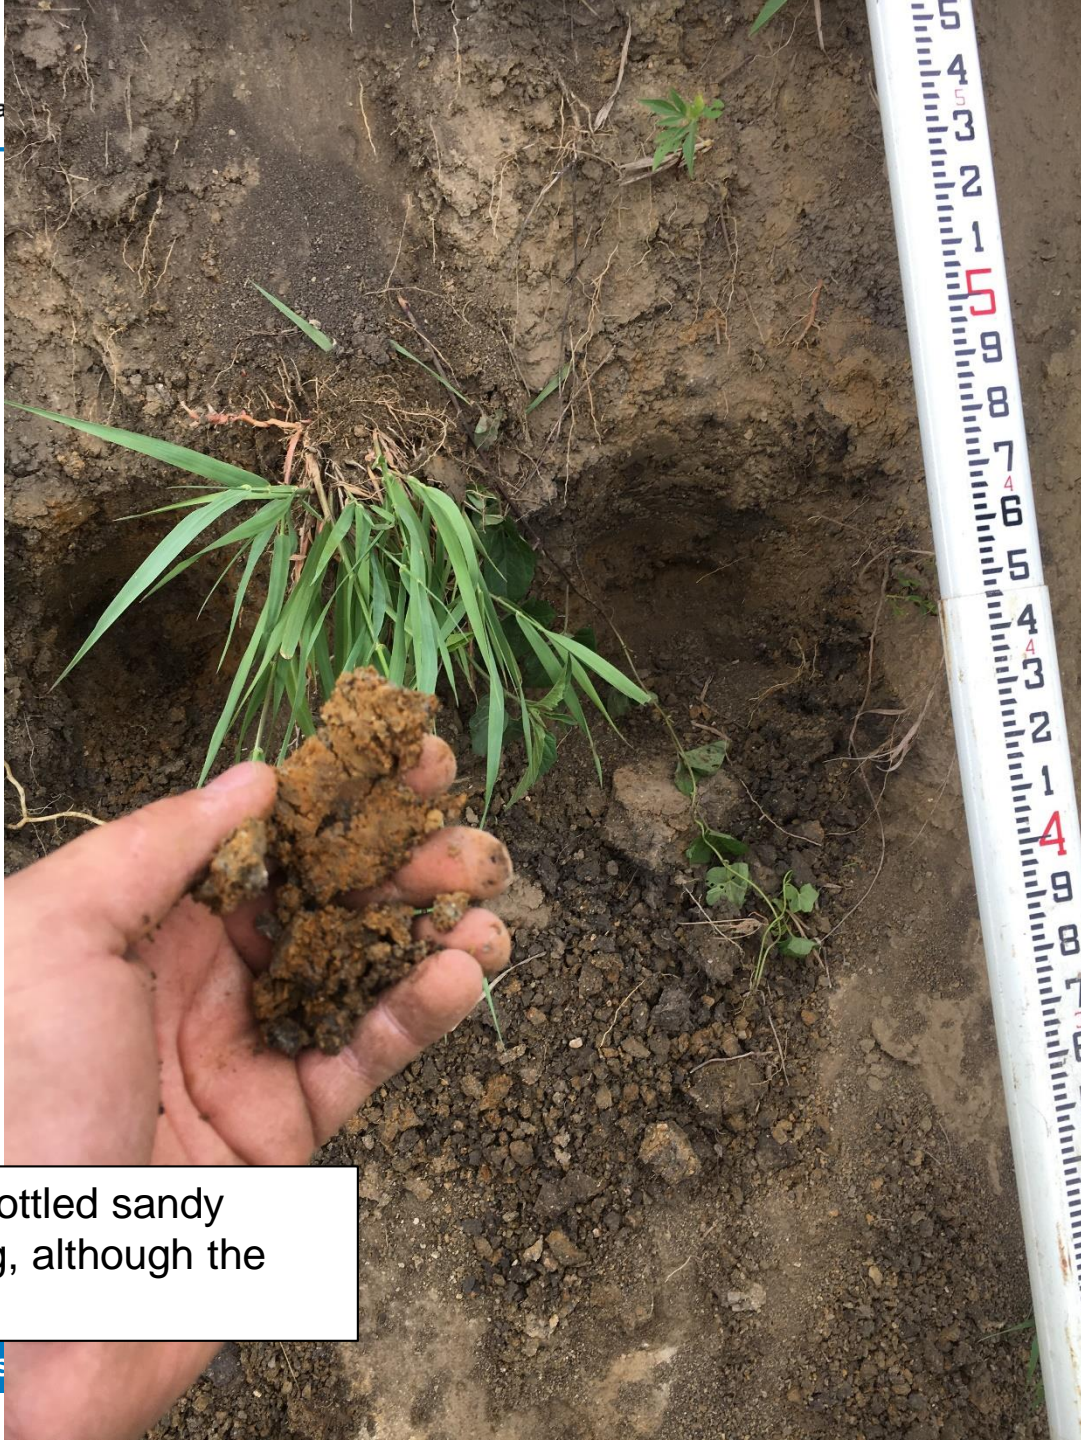
At the bank, red mottled sandy material is showing, although the material ribbons.

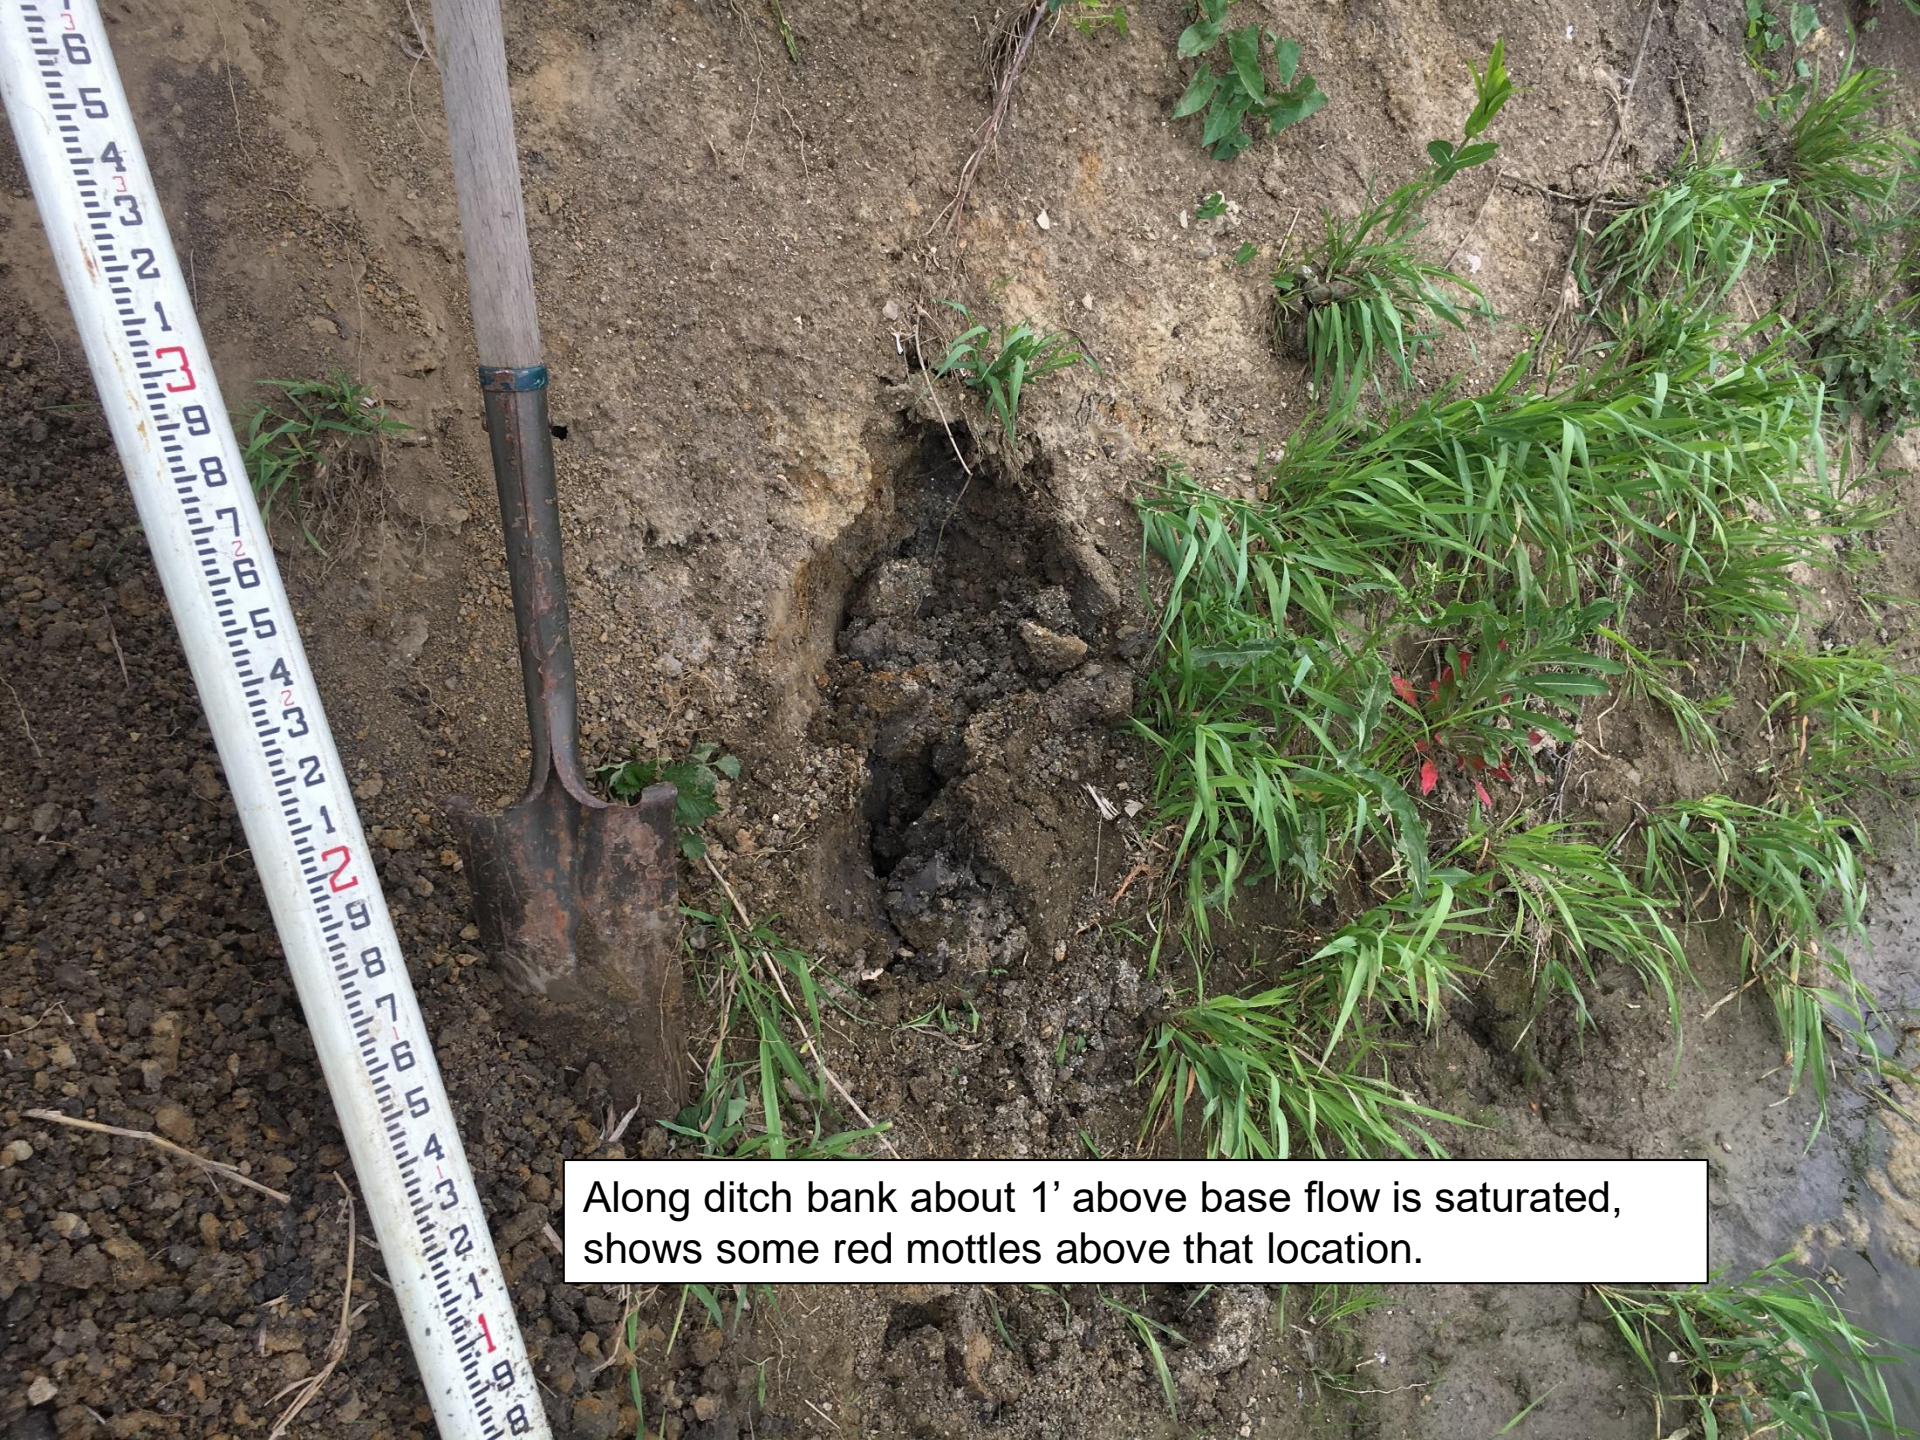
Along ditch bank about 1' above base flow is saturated, shows some red mottles above that location.

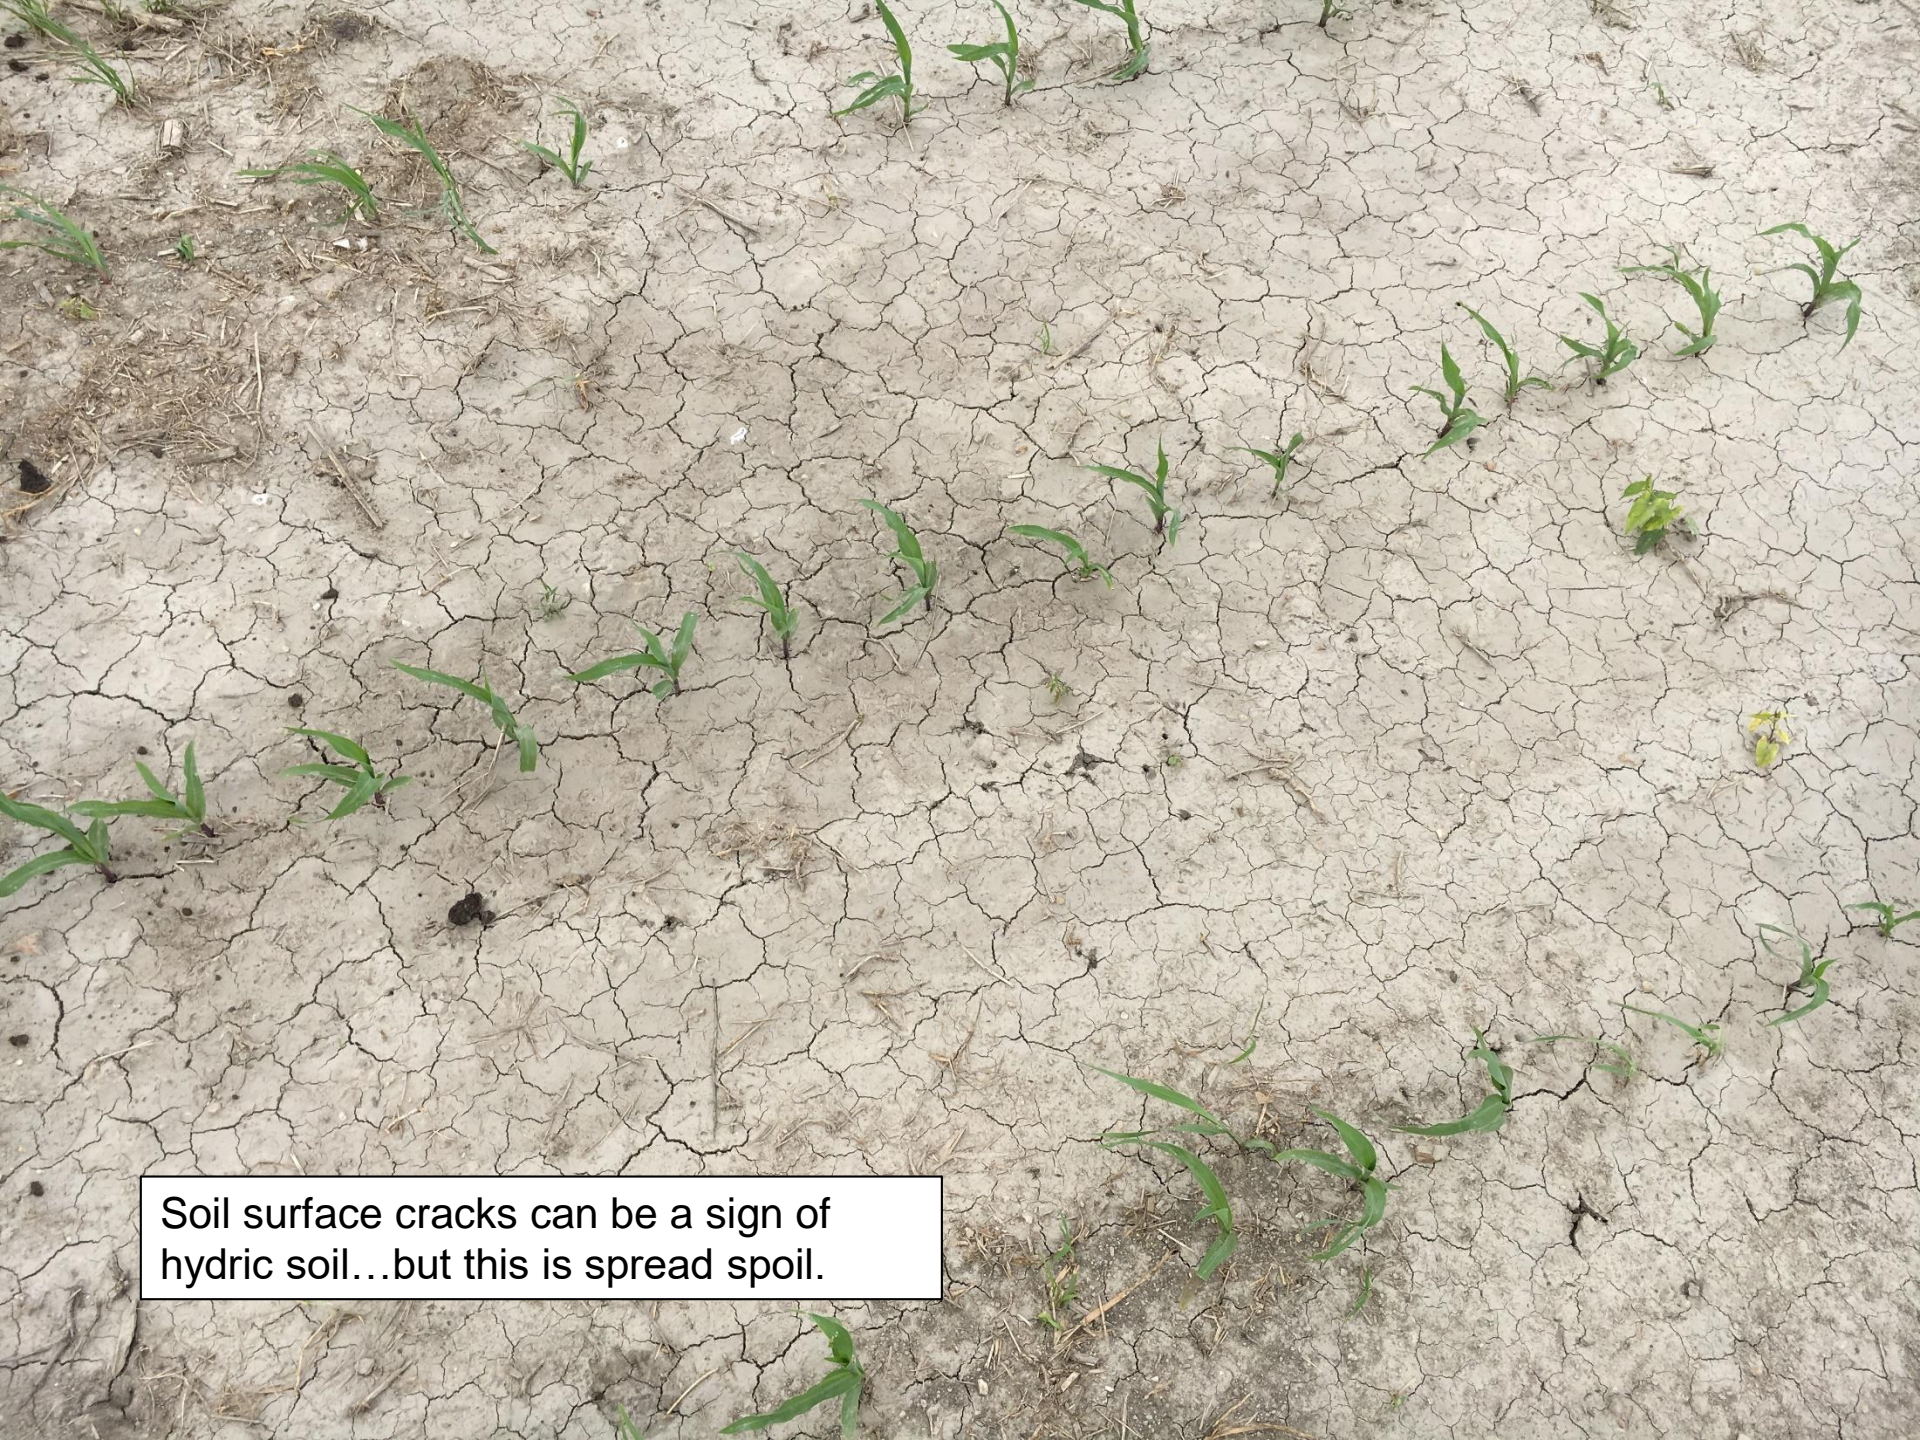
Tile probe brings up water droplets from 36" depth.

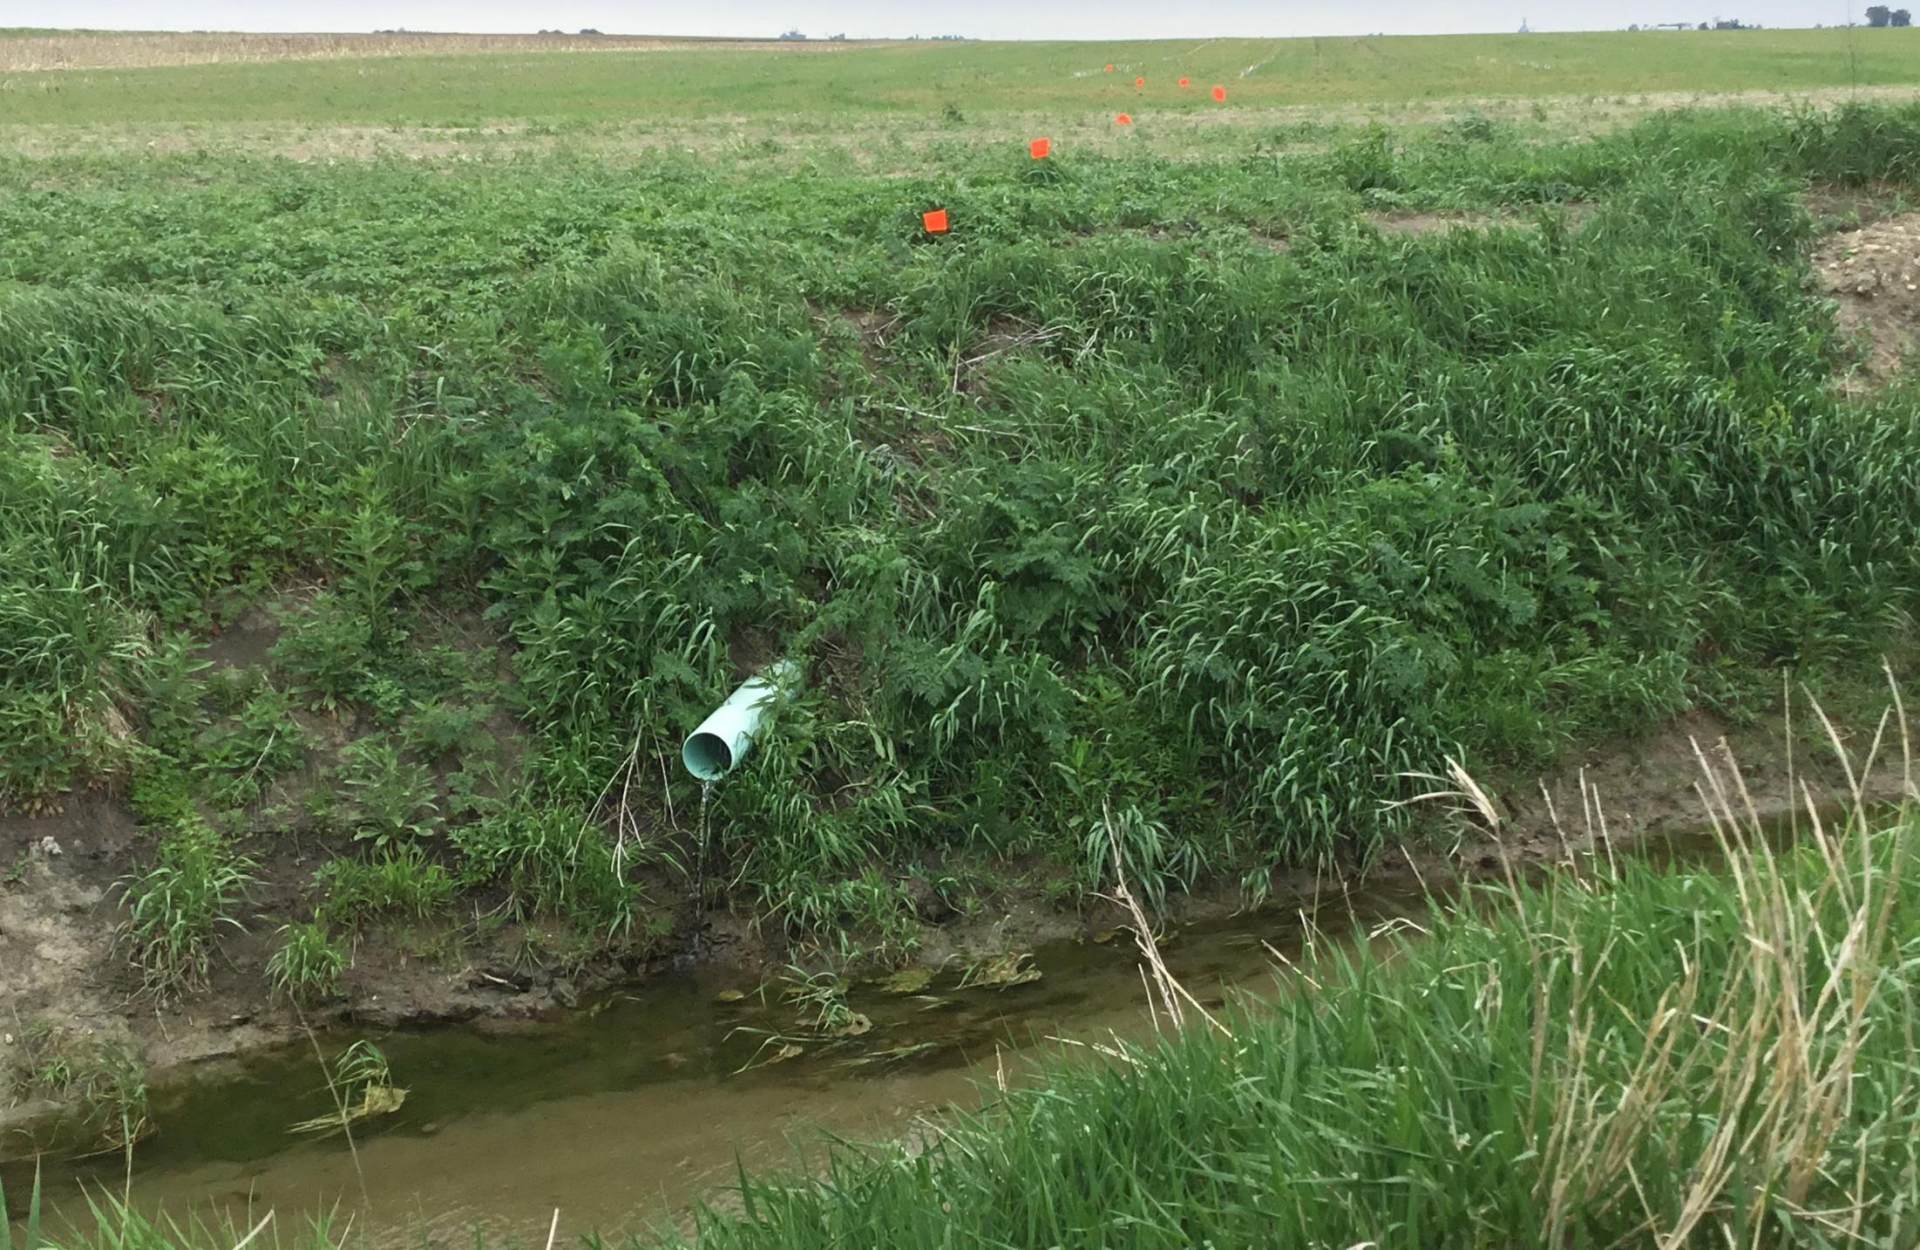
View of tile outlet from opposite bank. Note recent dredging.

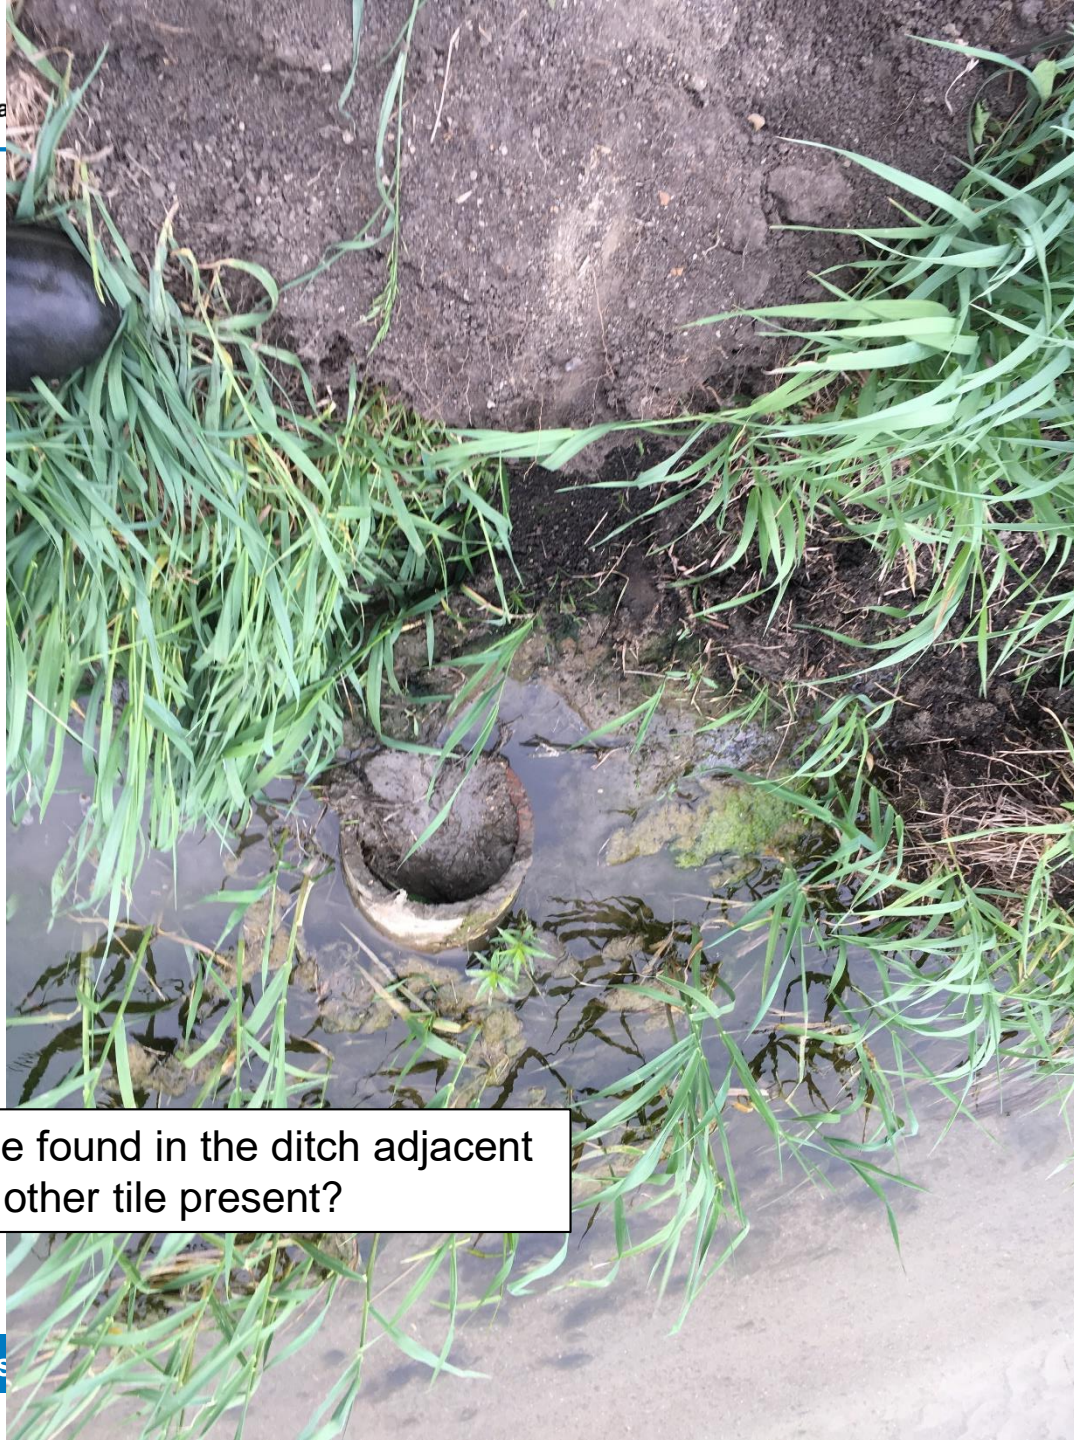
Piece of 8" clay tile found in the ditch adjacent to tile outlet. Any other tile present?

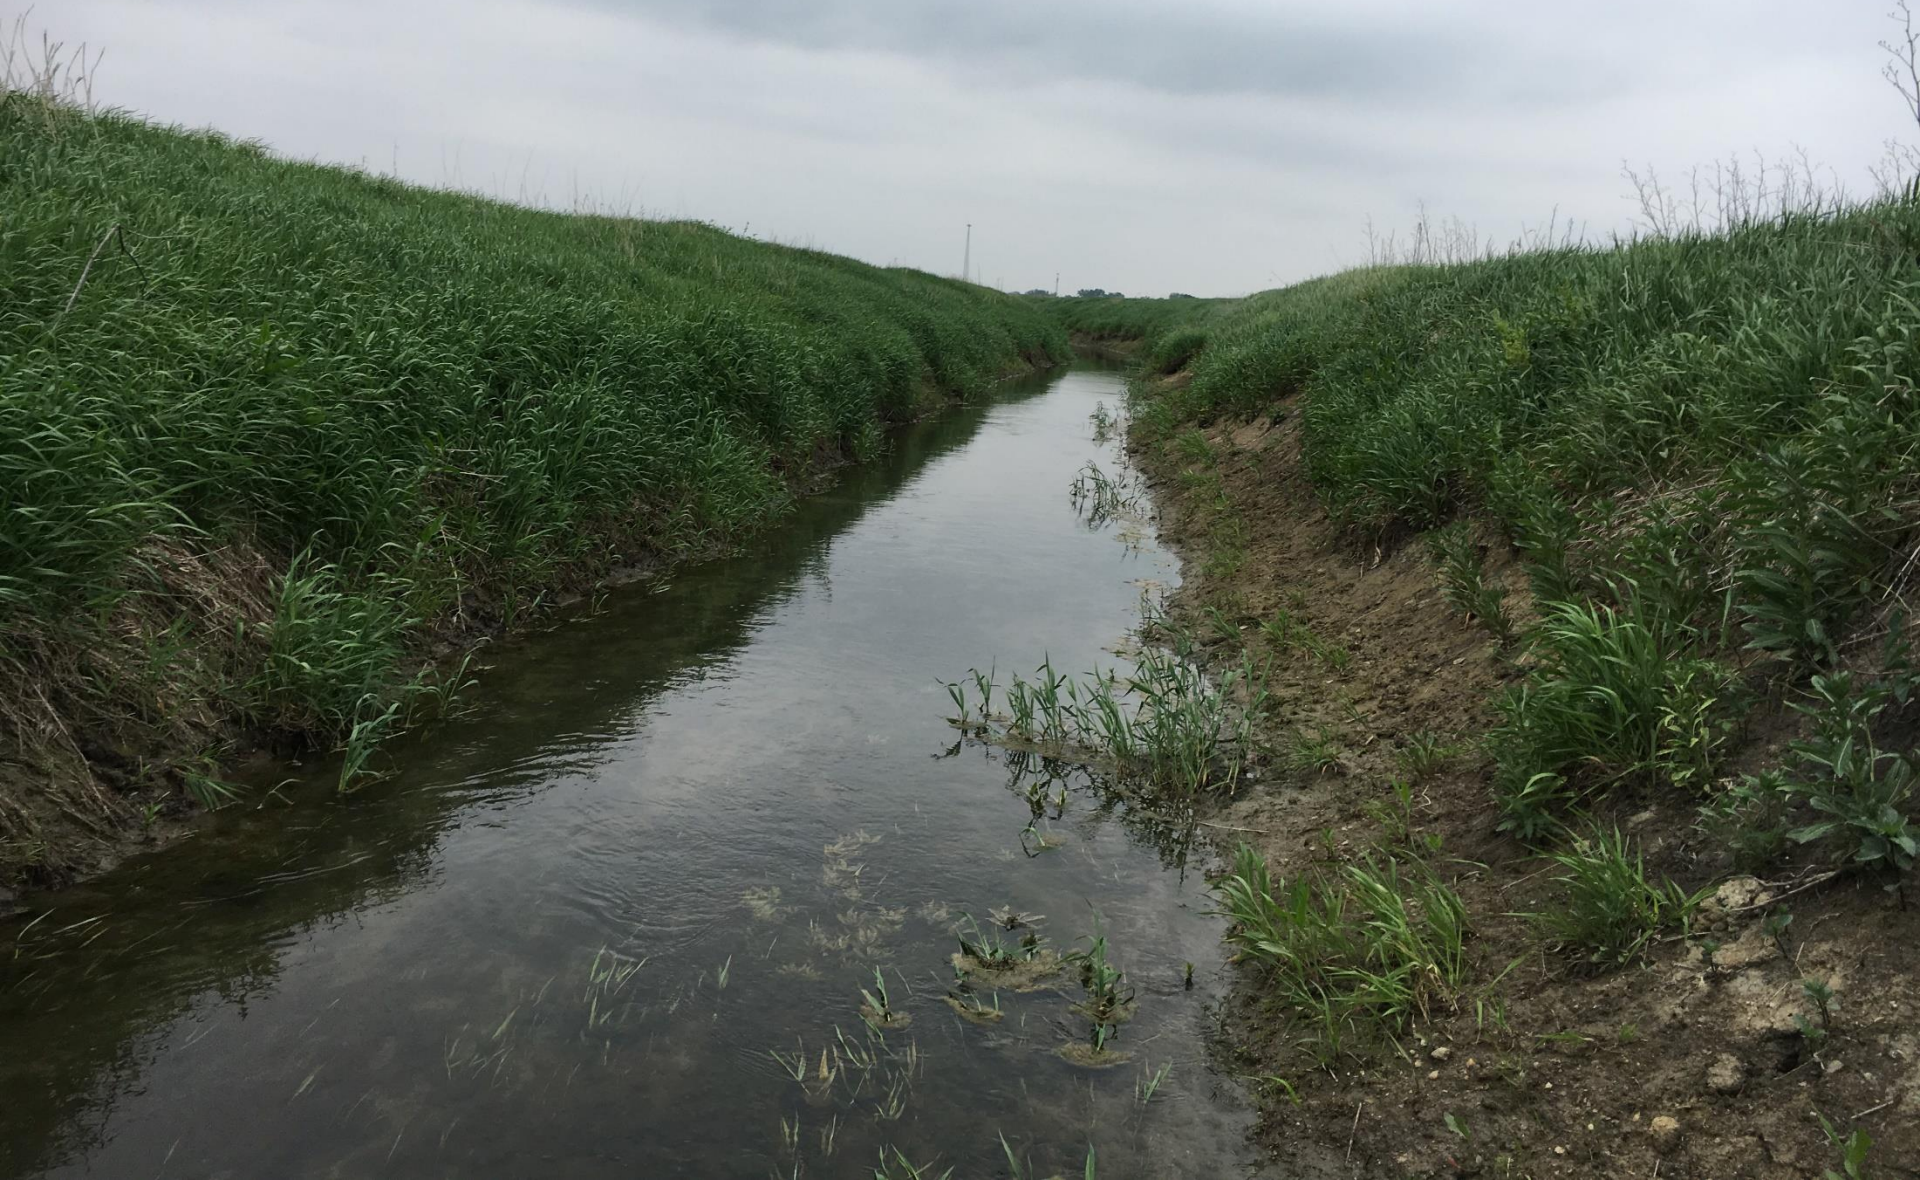
Looking downstream, are these banks stable?
