TNC: Lannon Farm Saturated Buffer

2019 Case Study

SATURATED BUFFER DESIGN

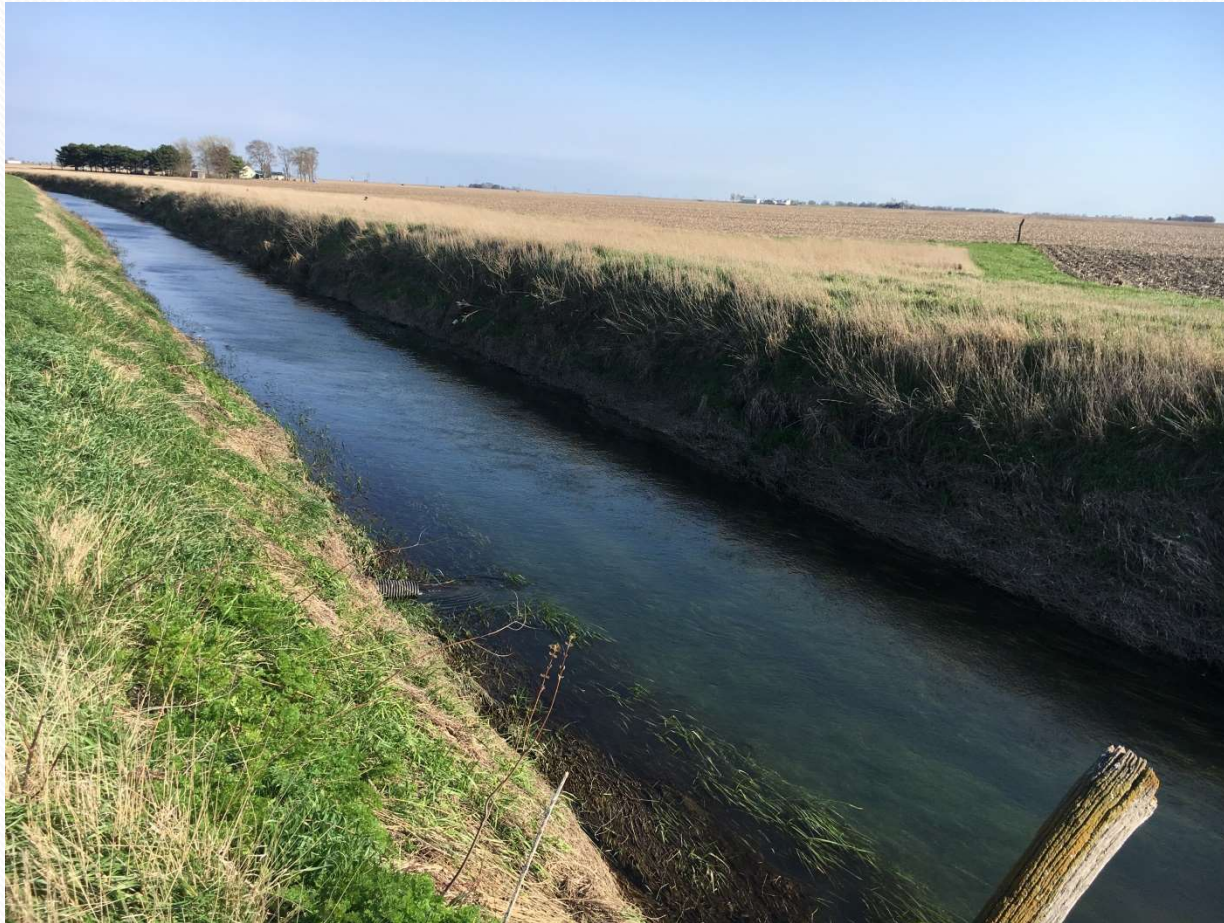
What is 'stable'?

Good

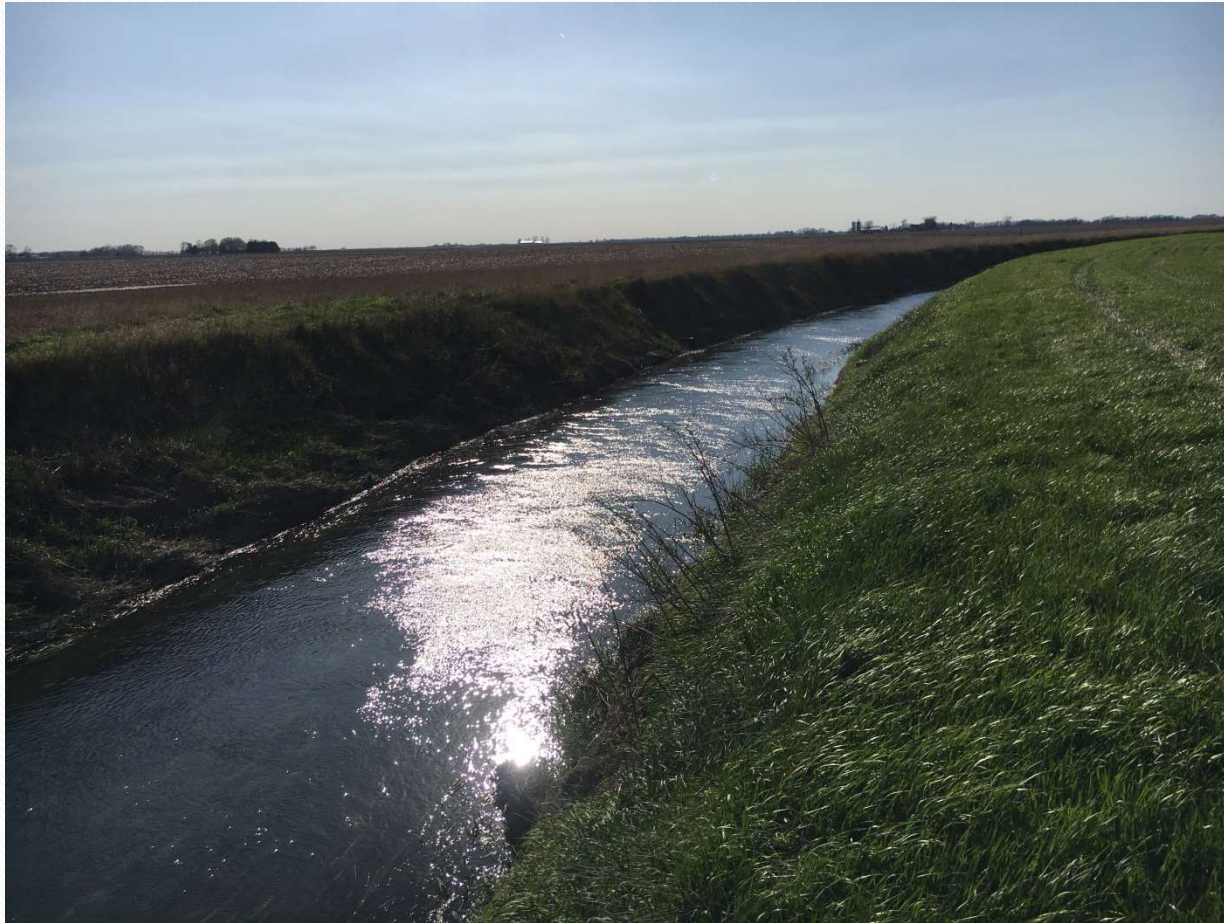
Good

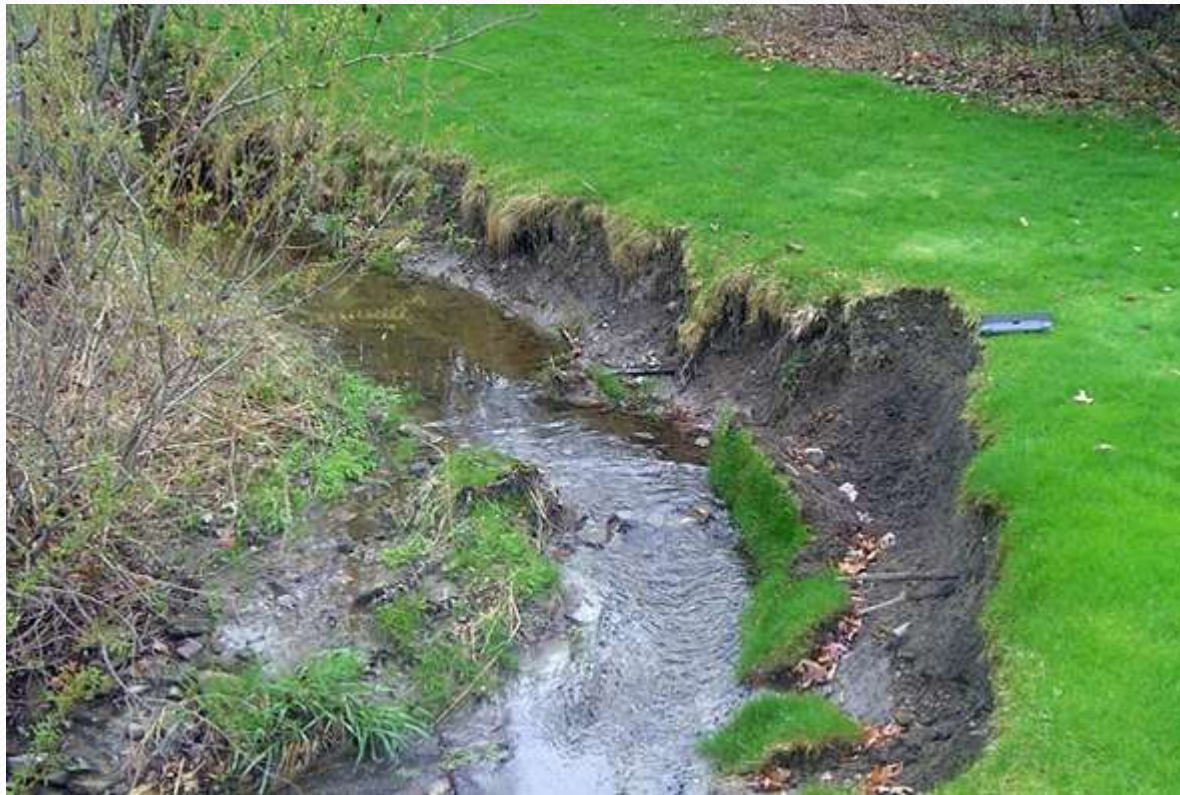
Bad

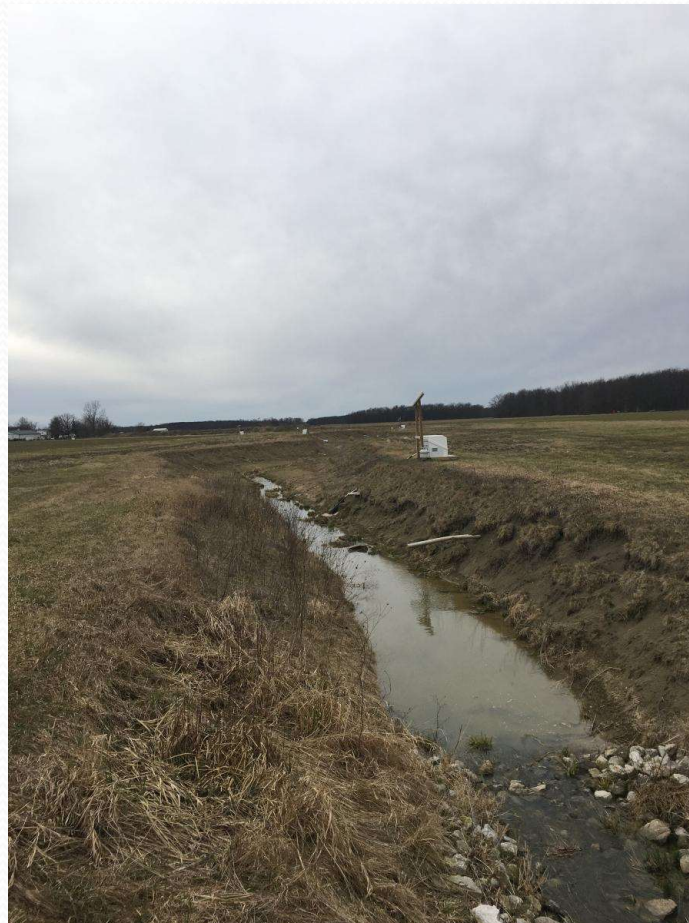
Bad

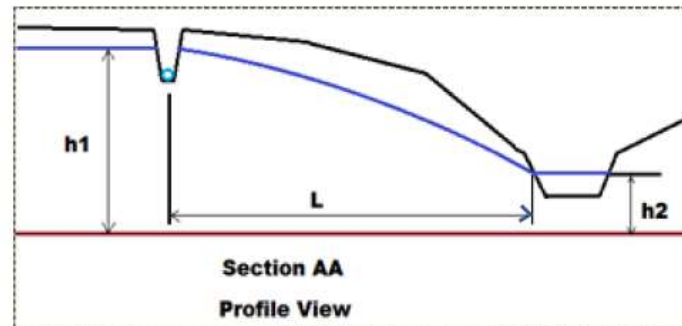
| Head at WCS, h_1 | 6.4 ft |
| Head at outlet, h_2 | 0.0 ft |
| Soil saturated hydraulic conductivity, K_{sat} ($\mu m/sec$) | 9.70 |
| Unit flow from distribution pipe, q (ft^3/hr per ft) | 0.059 |
| $q = \frac{K_{sat}}{2L}(h_1^2 - h_2^2)$ | |
| Distribution pipe length for min. design capacity | 1187 ft |
