Soil Report for Installation of Saturated Buffer System

Lannon Property, north of Longview, IL

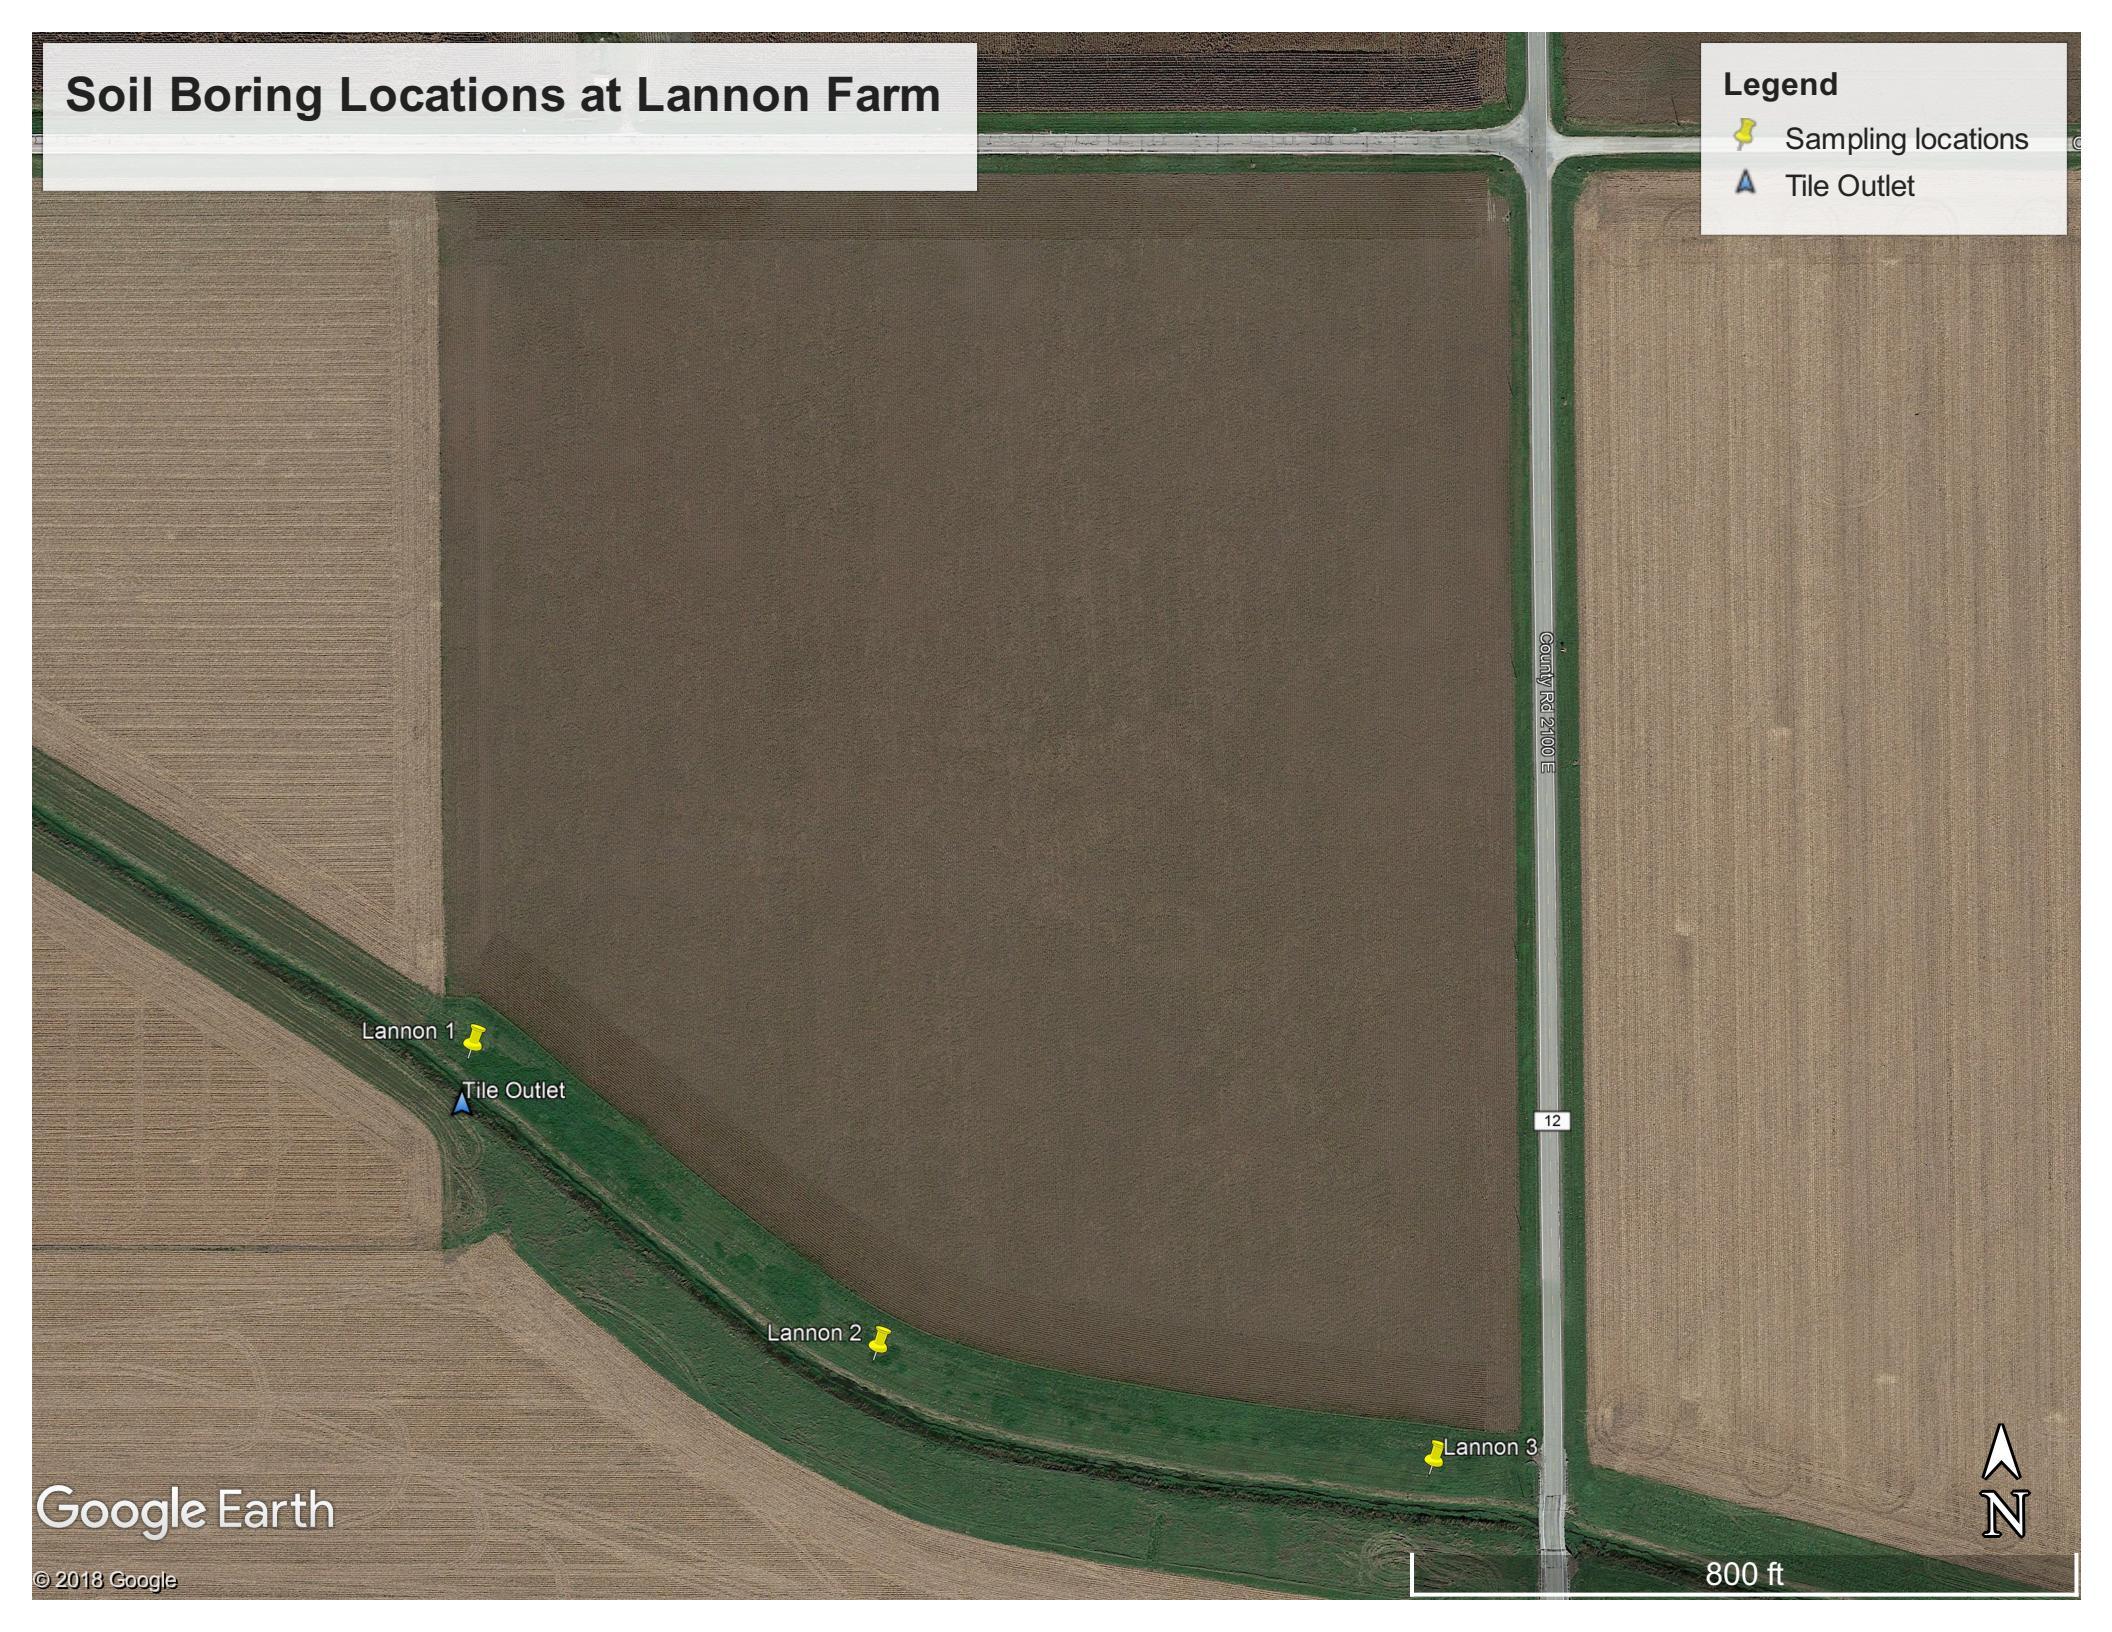
Three soil borings were placed across this vegetated buffer, labeled Lannon 1-3 from west to east. There is a tile entering the stream from the property to the northeast. As this is the likely placement area for the control structure for this saturated buffer, one boring (Lannon 1) was conducted approximately 20 feet north of the stream from the tile outlet. Additional borings were conducted approximately 600 feet southeast (downstream – Lannon 2) and approximately 1250 feet southeast (downstream – Lannon 3) from Lannon 1; both these borings were located approximately 30 feet north of the stream (see attached map). Due to the similarity of materials observed in each boring, no further borings were attempted. It is likely the soils in between are very similar to those described in this report.
